**NASA CONTRACTOR
REPORT**

NASA CR-1846

**THE EFFECT OF COMPOSITION ON
THE MECHANISM OF STRESS-CORROSION
CRACKING OF TITANIUM ALLOYS IN N_2O_4 ,
AND AQUEOUS AND HOT-SALT ENVIRONMENTS
(Part II)**

Prepared by
BATTELLE MEMORIAL INSTITUTE
Columbus, Ohio 43201
for

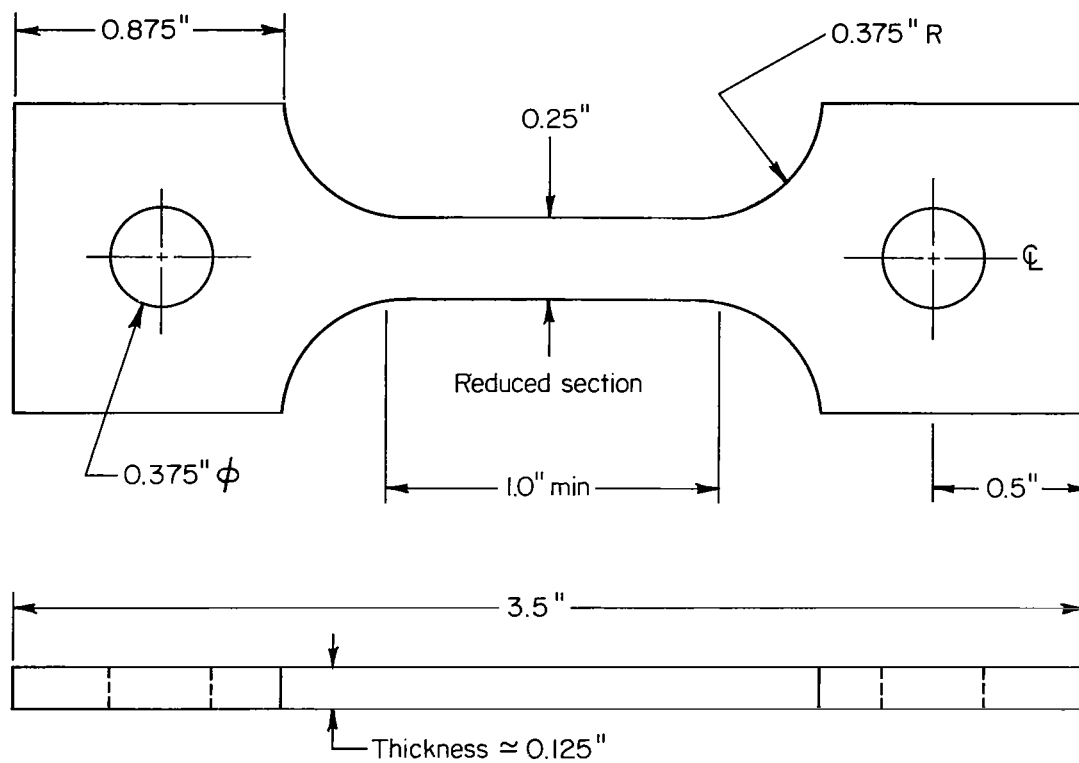
FIGURE 1. SPECIMEN GEOMETRY, SHEET TENSILE AND SHEET CREEP SPECIMENS

Profile surfaces machined; sheet surfaces ground.

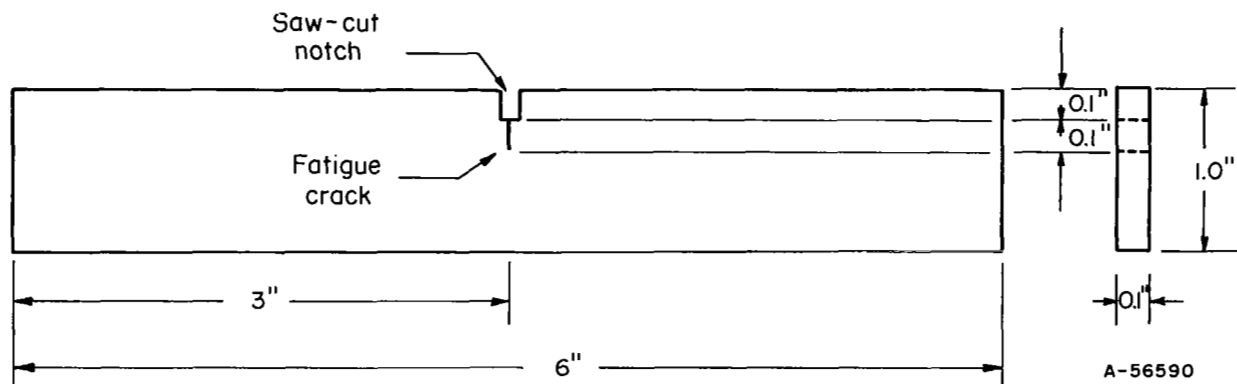
FIGURE 2. GEOMETRY OF PRECRACKED CANTILEVER TEST SPECIMEN

The single-edge notched, precracked, cantilever test⁽²⁾ was used to determine the fracture toughness and aqueous stress-corrosion susceptibility (3.5 percent NaCl) of the experimental alloys. The same procedure was followed as that described in previous reports⁽¹⁾. Dimensions of the 1/8- and 1/4-inch-thick test specimens were generally as shown in Figure 2. Special tests were conducted using side-notched specimens with the geometry depicted in Figure 3, and 1/2-inch-thick specimens of

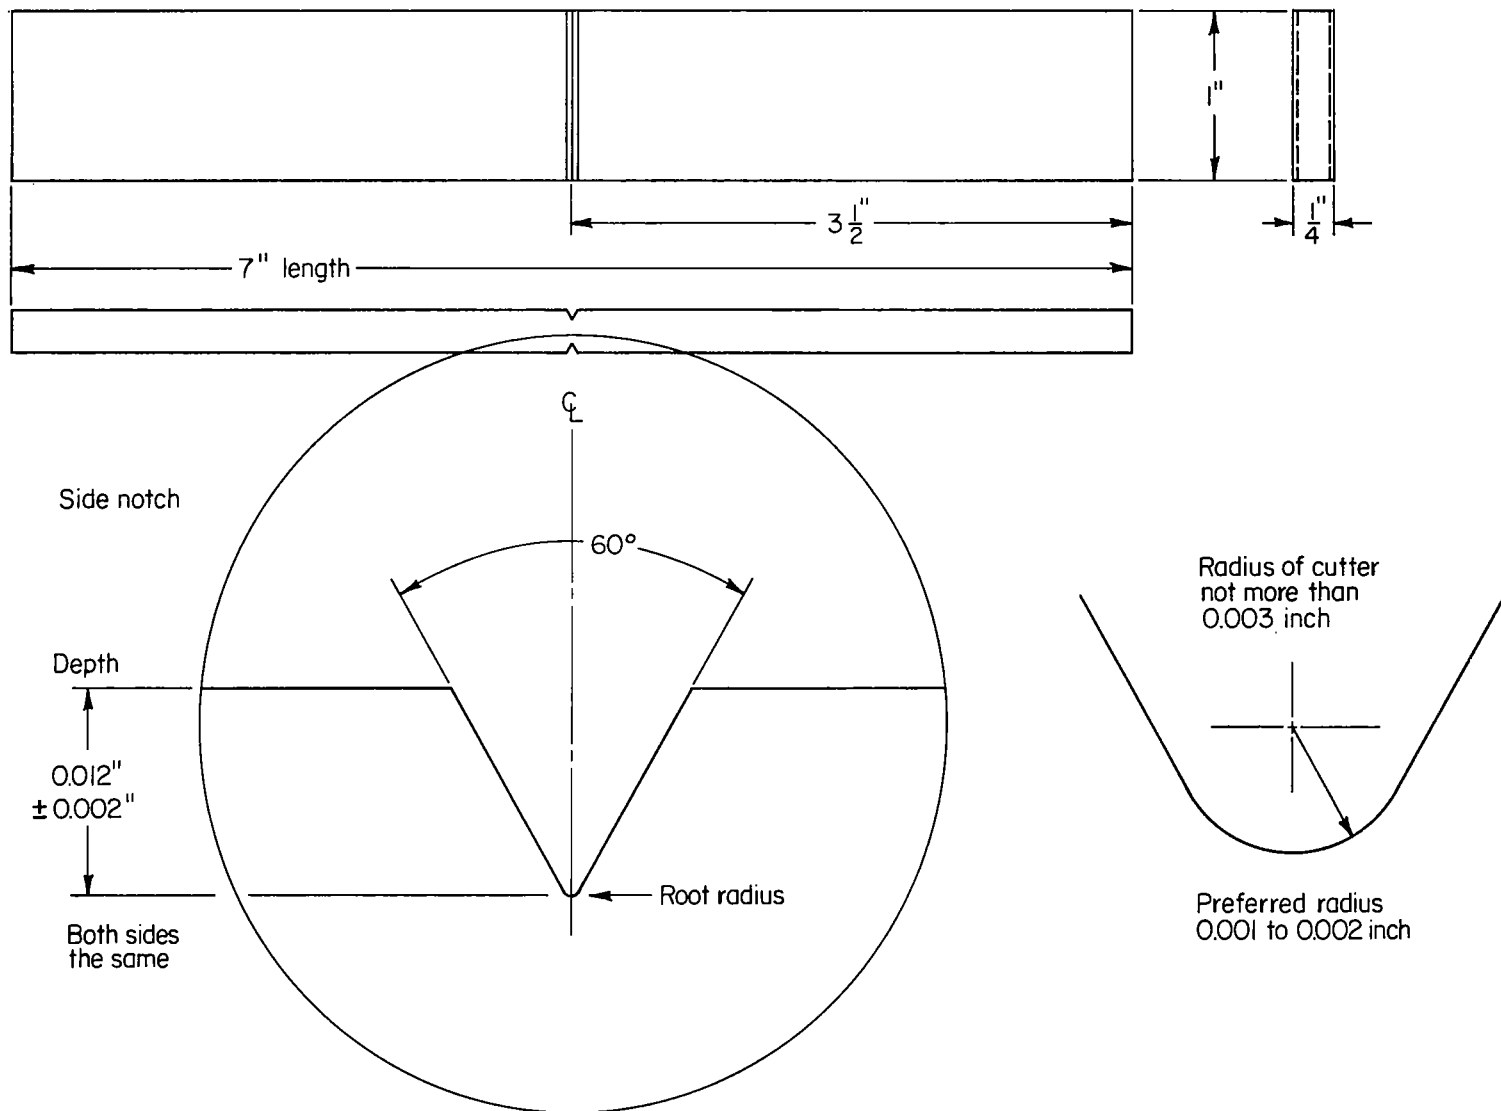
FIGURE 3. GEOMETRY OF SIDE-NOTCHED SPECIMENS (BOTH SIDES NOTCHED)

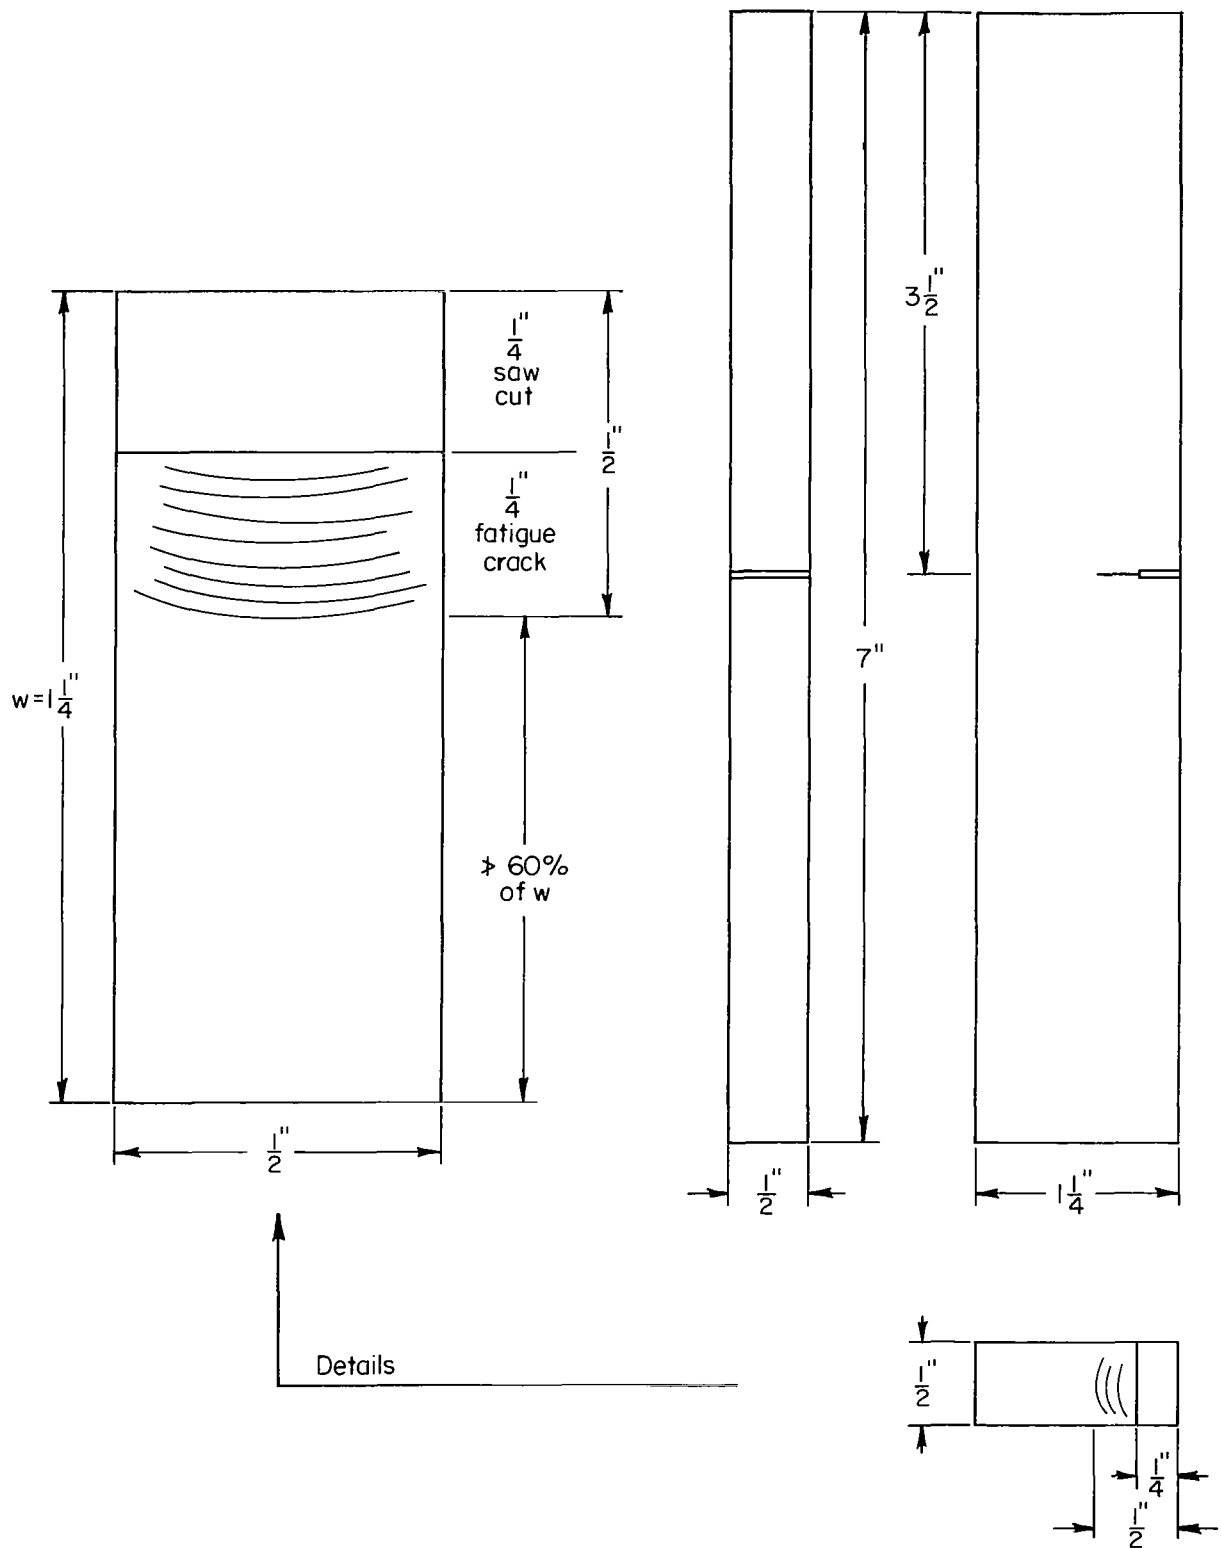
FIGURE 4. GEOMETRY OF 1/2-INCH-THICK SPECIMENS, CANTILEVER NOTCH BEND TEST

commercial-grade Ti-4Al-3Mo-1V alloy as shown in Figure 4. The general test procedure for step-loaded tests was to add an initial load, estimated to result in a stress intensity of about 10 ksi $\sqrt{\text{inch}}$ below the stress intensity for failure, and then to apply additional load in increments equivalent to stress-intensity increments of 1 to 2 ksi $\sqrt{\text{inch}}$ at intervals of 2 to 5 minutes until crack propagation and failure occurred. Tests at constant load were also conducted where exposures to the environment were for 6 hours (a few tests were discontinued in shorter times). The data generated in these tests are given in Tables 6, 7, and 8.

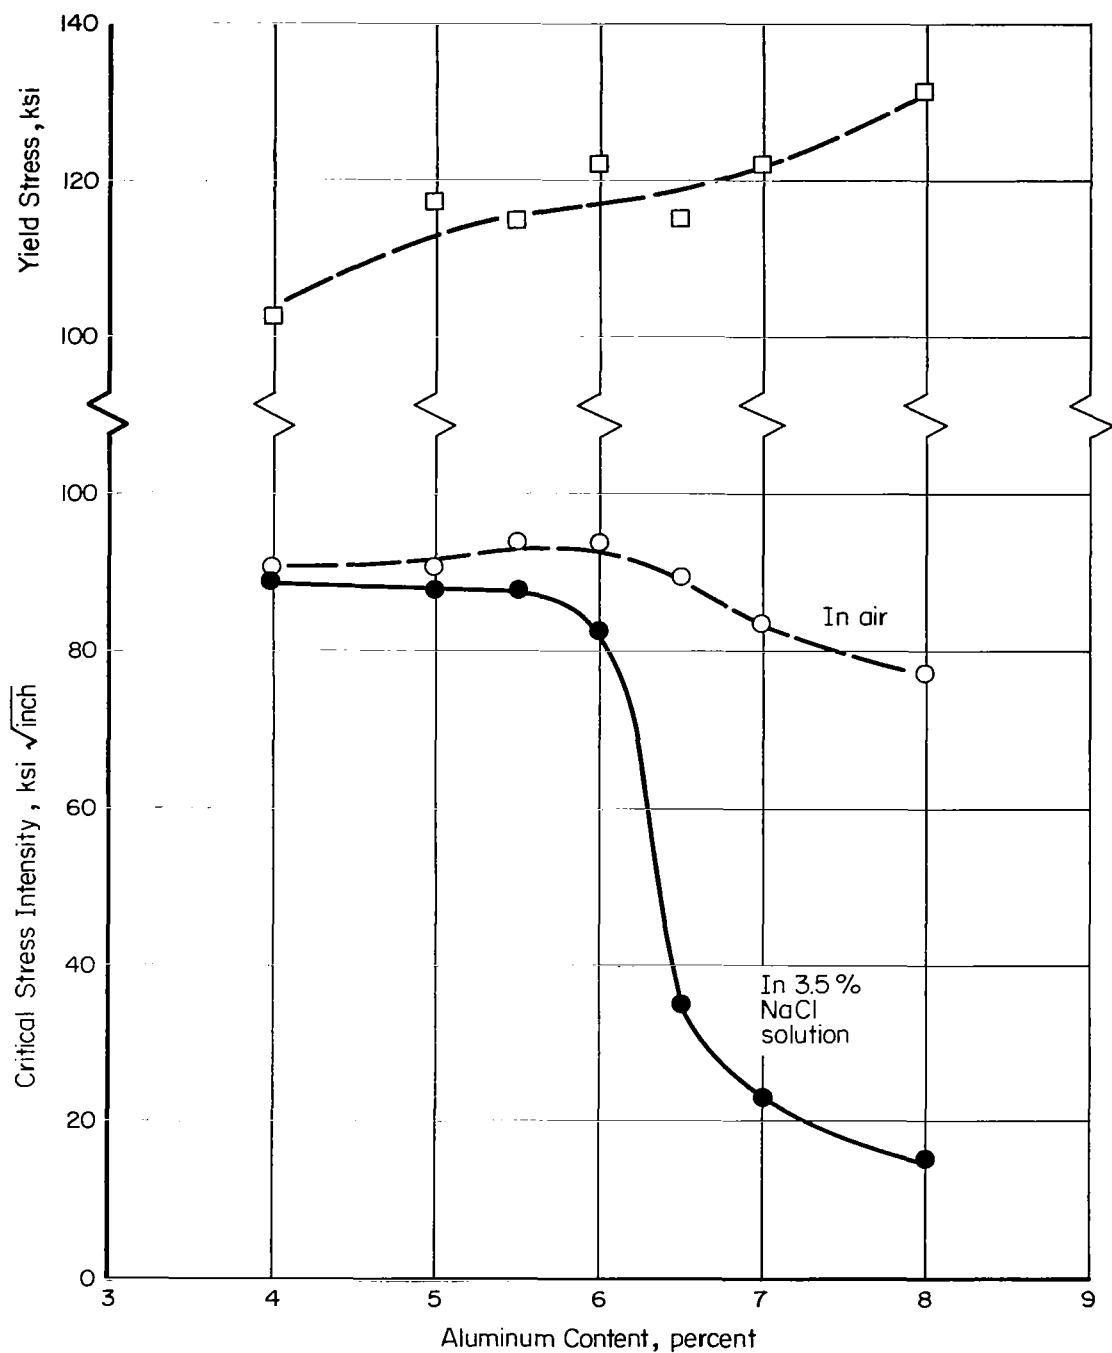
FIGURE 5. EFFECT OF ALUMINUM CONTENT ON THE STRENGTH, TOUGHNESS, AND STRESS-CORROSION SUSCEPTIBILITY OF Ti-1.5Mo-0.5V-BASE ALLOYS (NOMINALLY 1000 PPM OXYGEN)

Data are for 1/8-inch-thick specimens; incremental load tests.

The effect of aluminum content on the stress-corrosion susceptibility of Ti-1.5Mo-0.5 V base alloys is clearly evident when the above and prior⁽¹⁾ data are plotted as in Figure 5. In this plot of the data for the 1/8-inch-thick specimen, the air toughness

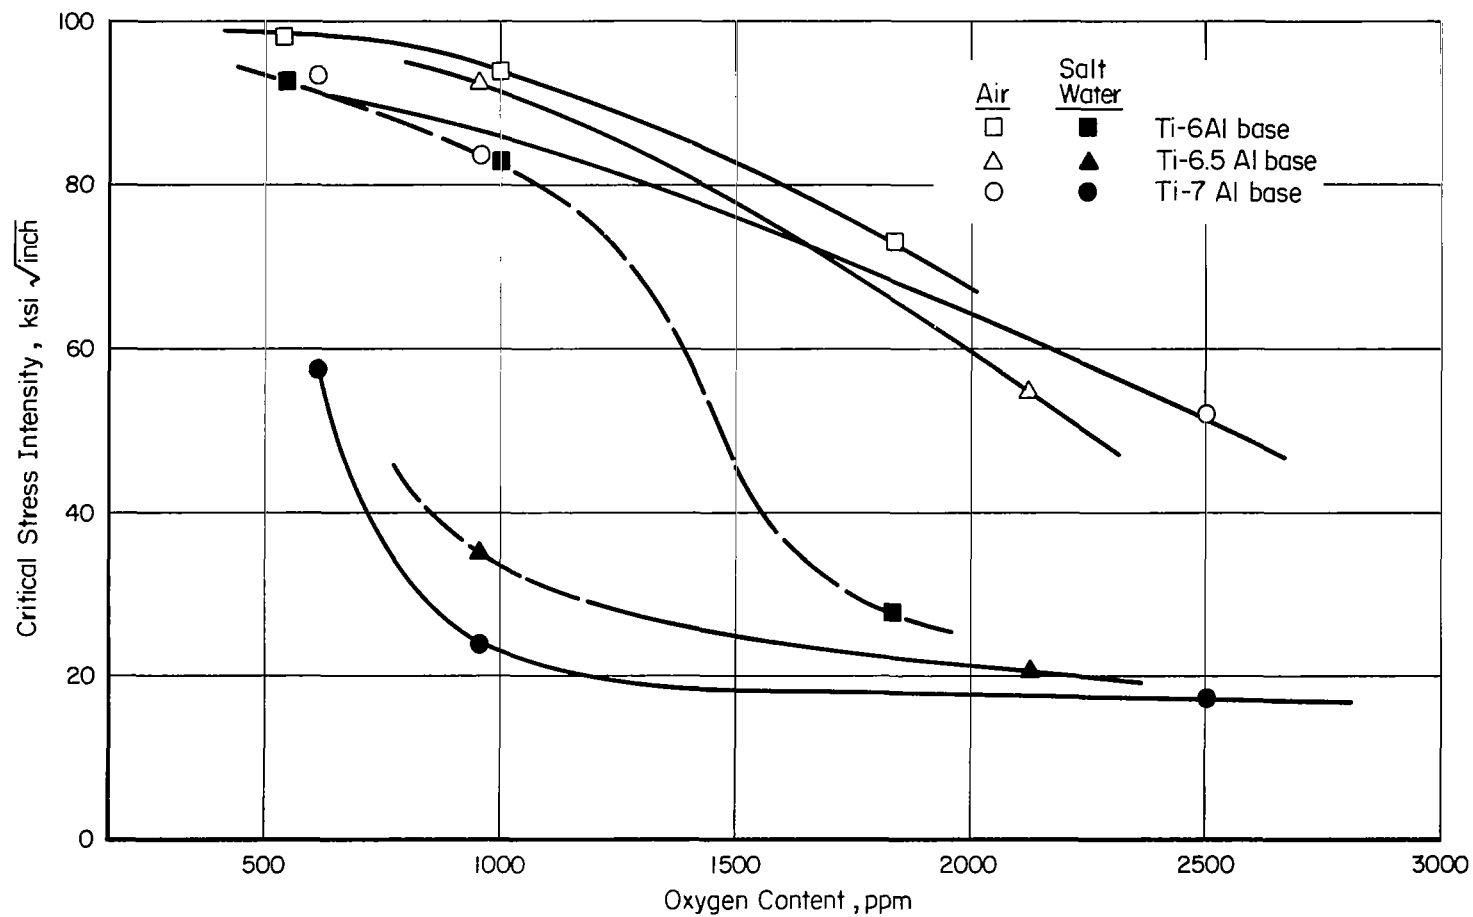
FIGURE 6. EFFECT OF OXYGEN CONTENT ON THE TOUGHNESS AND STRESS-CORROSION SUSCEPTIBILITY OF Ti-(6, 6.5, 7)Al-1.5Mo-0.5V ALLOYS

Data are for 1/8-inch-thick specimens; incremental load tests.

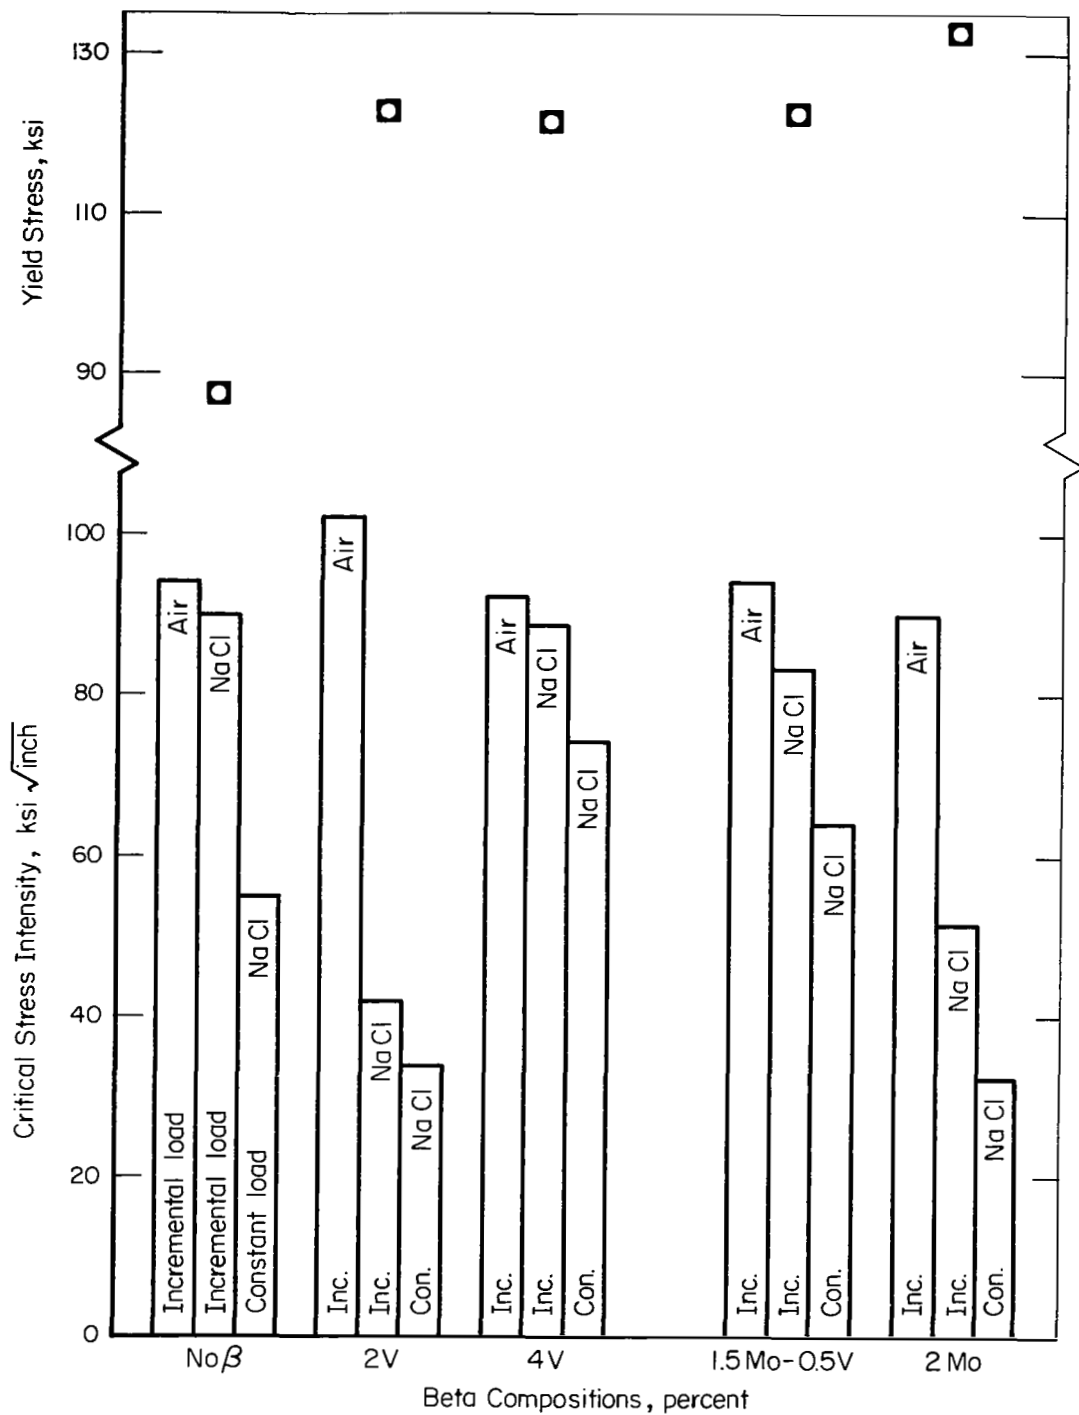
FIGURE 7. EFFECT OF BETA STABILIZER AMOUNT AND KIND ON YIELD STRENGTH, TOUGHNESS, AND STRESS-CORROSION SUSCEPTIBILITY OF Ti-6Al BASE ALLOYS (1000 PPM O₂)

Data are for 1/8-inch-thick specimens.

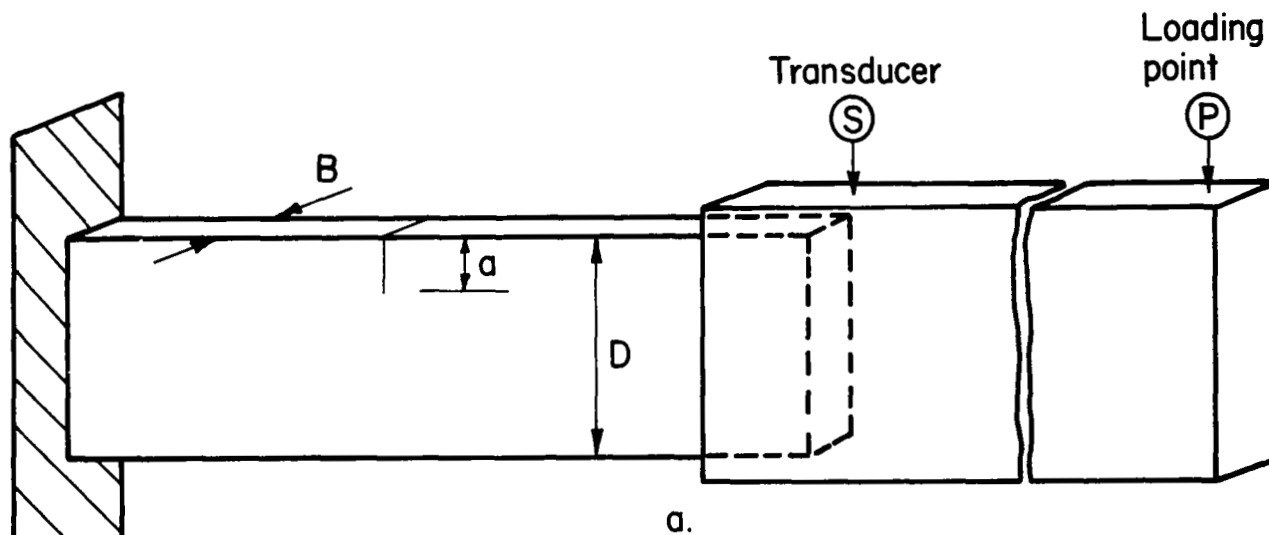
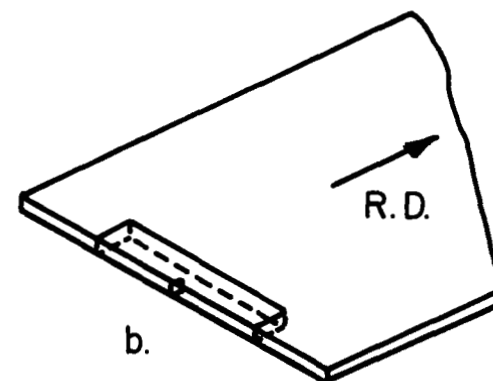
$$K_I = \frac{4.12 M \sqrt{\alpha^{-3} - \alpha^3}}{BD^{3/2}}$$

$$\alpha = 1 - a/D$$

FIGURE 8. SPECIMEN GEOMETRY AND LOADING ARRANGEMENT

The specimen geometry and loading arrangement was such that the plane subjected to the maximum tensile stress (which coincided with the plane of the crack) was the plane containing the rolling direction and the normal to the surface of the rolled plate. The crack propagation direction was parallel to the rolling direction (Figure 8).

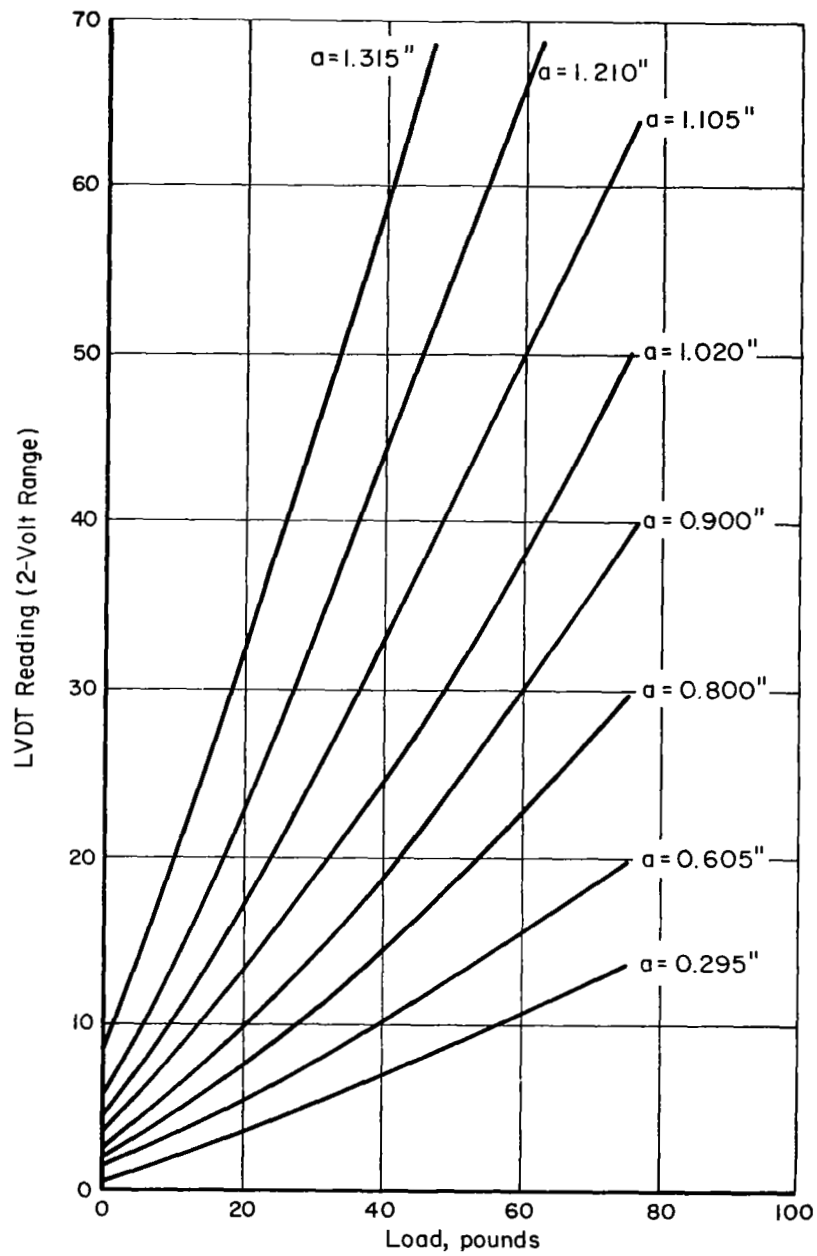
FIGURE 9. CALIBRATION CHART FOR CRACK VELOCITY MEASUREMENTS

transformer (LVDT) to a pen recorder. The transducer continuously monitored the lever-arm deflection, and these data could be converted to measurements of crack length after calibration of the apparatus. The apparatus was calibrated by placing a specimen containing a precrack (saw cut and fatigue crack) of known length in position and zeroing the recorder. The specimen was then loaded in air and the LVDT reading was recorded for each load. The specimen was loaded and unloaded several times to verify that the relationship between LVDT reading and load was single-valued for a constant crack length. Next a bottle of salt water was placed around the crack, a load was applied, and the crack was allowed to grow approximately 0.1 inch in length. The salt water was then removed, the specimen washed and dried, and the LVDT-load relationship determined for the new crack length. This procedure was repeated until a family of curves was generated representing the relationship between LVDT reading and load for various crack lengths ranging from 0.30 inch to 1.3 inch (Figure 9). The actual tests were carried out by loading the specimen incrementally until subcritical crack growth began. The crack was then allowed to propagate at constant load until complete fracture occurred. A calibration curve for each test was constructed by drawing a vertical line on the calibration chart (Figure 9) corresponding to the load used during crack propagation, and reading off the LVDT reading as a function of crack length. The LVDT readings which were recorded during the test could then be converted to crack lengths, and the crack velocities calculated from plots of crack length against time. For each test, two checks were made on the accuracy of the calibration curve. The crack lengths before and after the test were measured accurately, and the LVDT readings given by the calibration curve were compared with the actual readings. In most cases these comparisons showed good agreement (within 10 percent). Whenever there was a larger discrepancy, the data were discarded.

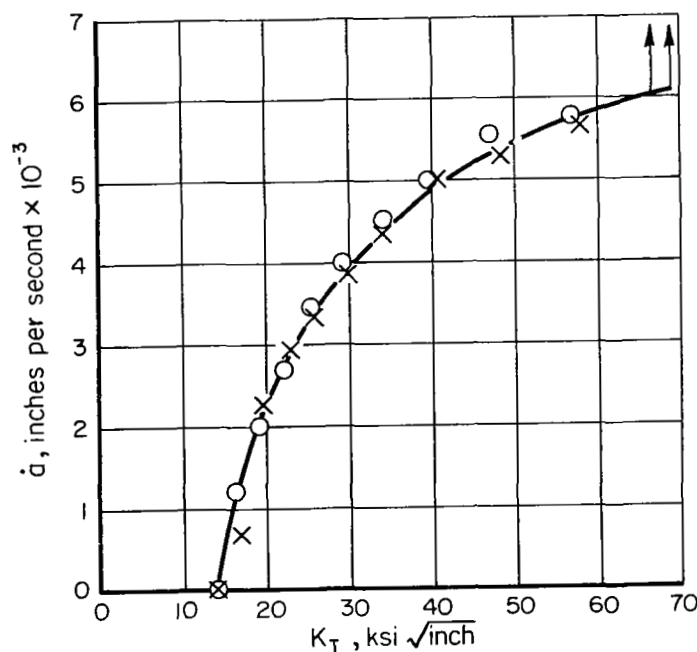
FIGURE 10. SUBCRITICAL-CRACK VELOCITIES FOR Ti-8Al-1Mo-1V, IN 3.5 PERCENT NaCl, AT ROOM TEMPERATURE

Crack-Velocity Measurements. In a single-edge-notched cantilever test, the stress intensity at the crack tip, K_I , increases continuously as the crack propagates. Thus, for each combination of environmental conditions the relationship between crack velocity and stress intensity could be determined from a single test. All of the results are presented as plots of crack velocity, \dot{a} , against K_I . Typical results for tests performed under standard conditions (room temperature, 3.5 percent NaCl) are shown in Figure 10. Data from two independent tests are shown to illustrate that the results were quite reproducible. (The "data points" are somewhat arbitrary since they were calculated from selected points on the continuous record of LVDT readings.) The curve in Figure 10 shows several fractures which appear to be characteristic of subcritical crack propagation in titanium alloys in aqueous environments:

- (1) There was a minimum stress intensity, $K_{I_{SCC}}$, which had to be exceeded before subcritical cracking began
- (2) At the onset of subcritical cracking, \dot{a} increased rapidly with increasing K_I , but the dependence of \dot{a} on K_I became less at higher values of K_I when \dot{a} approached a constant value, \dot{a}^0
- (3) Rapid fracture occurred when the stress intensity became equal to the fracture toughness, K_{I_x}

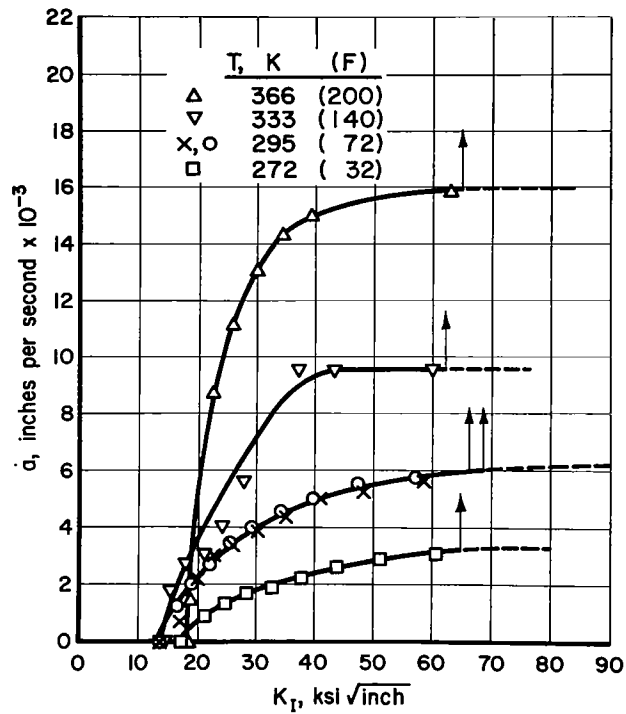
FIGURE 11. EFFECT OF ENVIRONMENT TEMPERATURE ON SUBCRITICAL-CRACK VELOCITIES

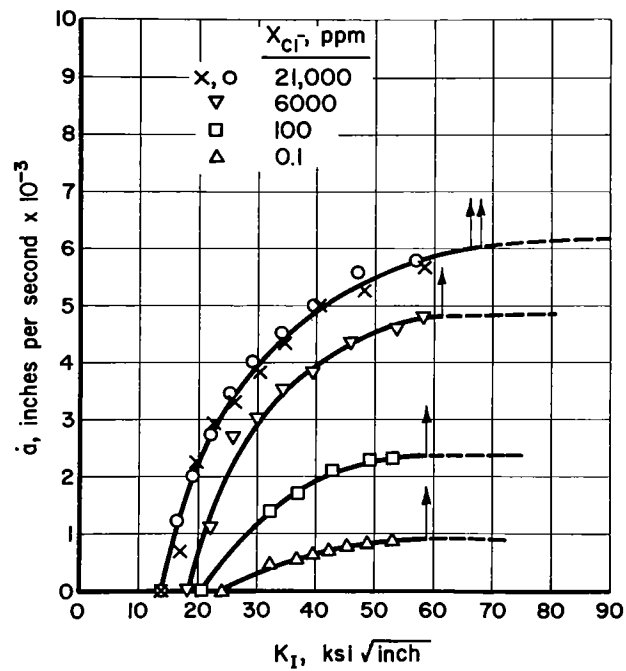
FIGURE 12. EFFECT OF BULK CHLORIDE-ION CONCENTRATION ON SUBCRITICAL-CRACK VELOCITIES

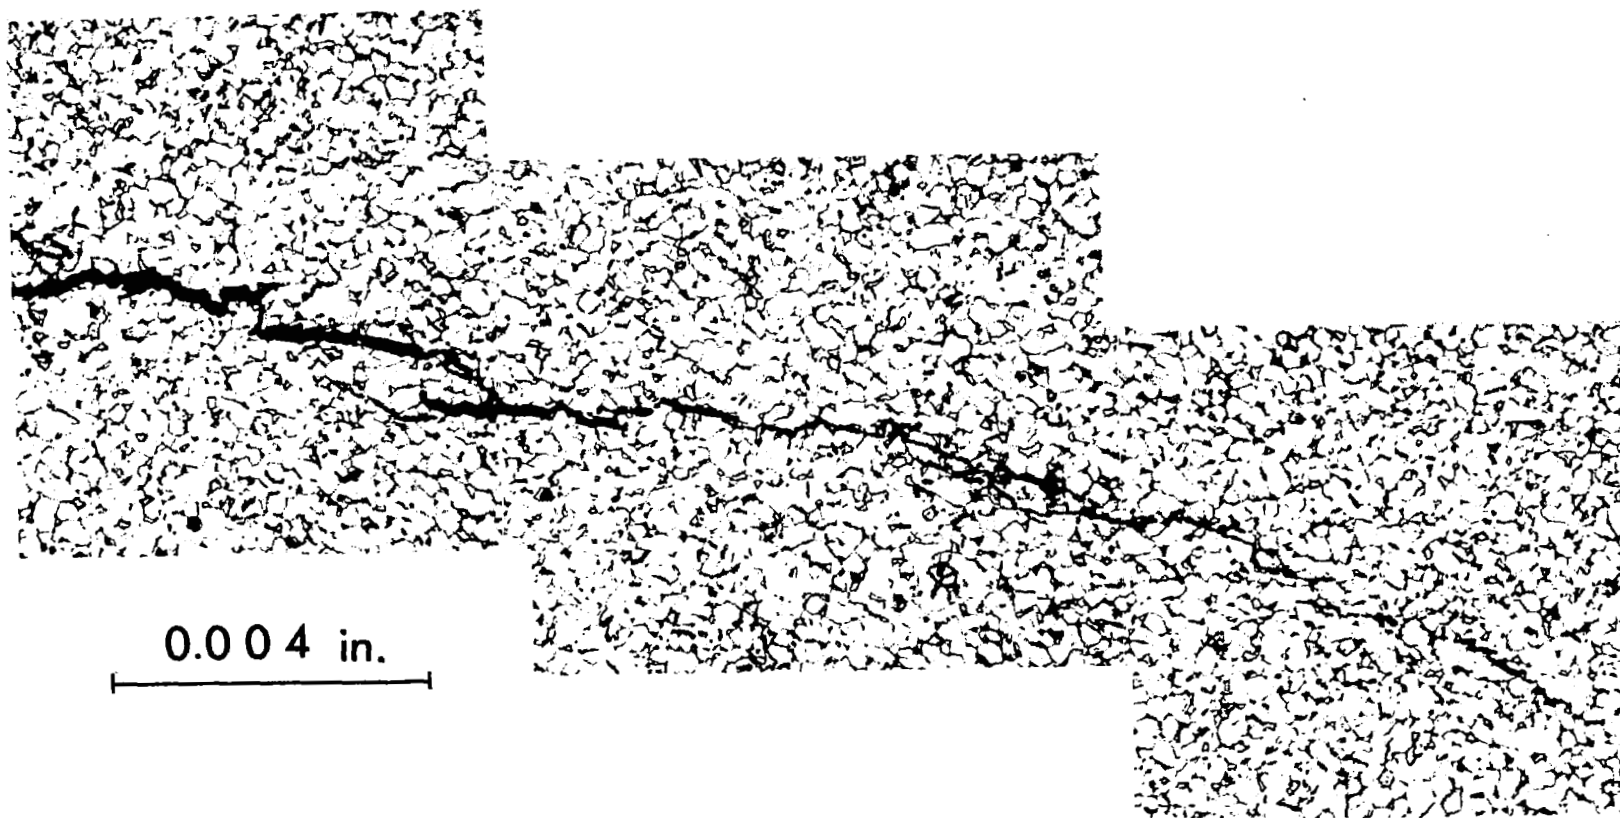
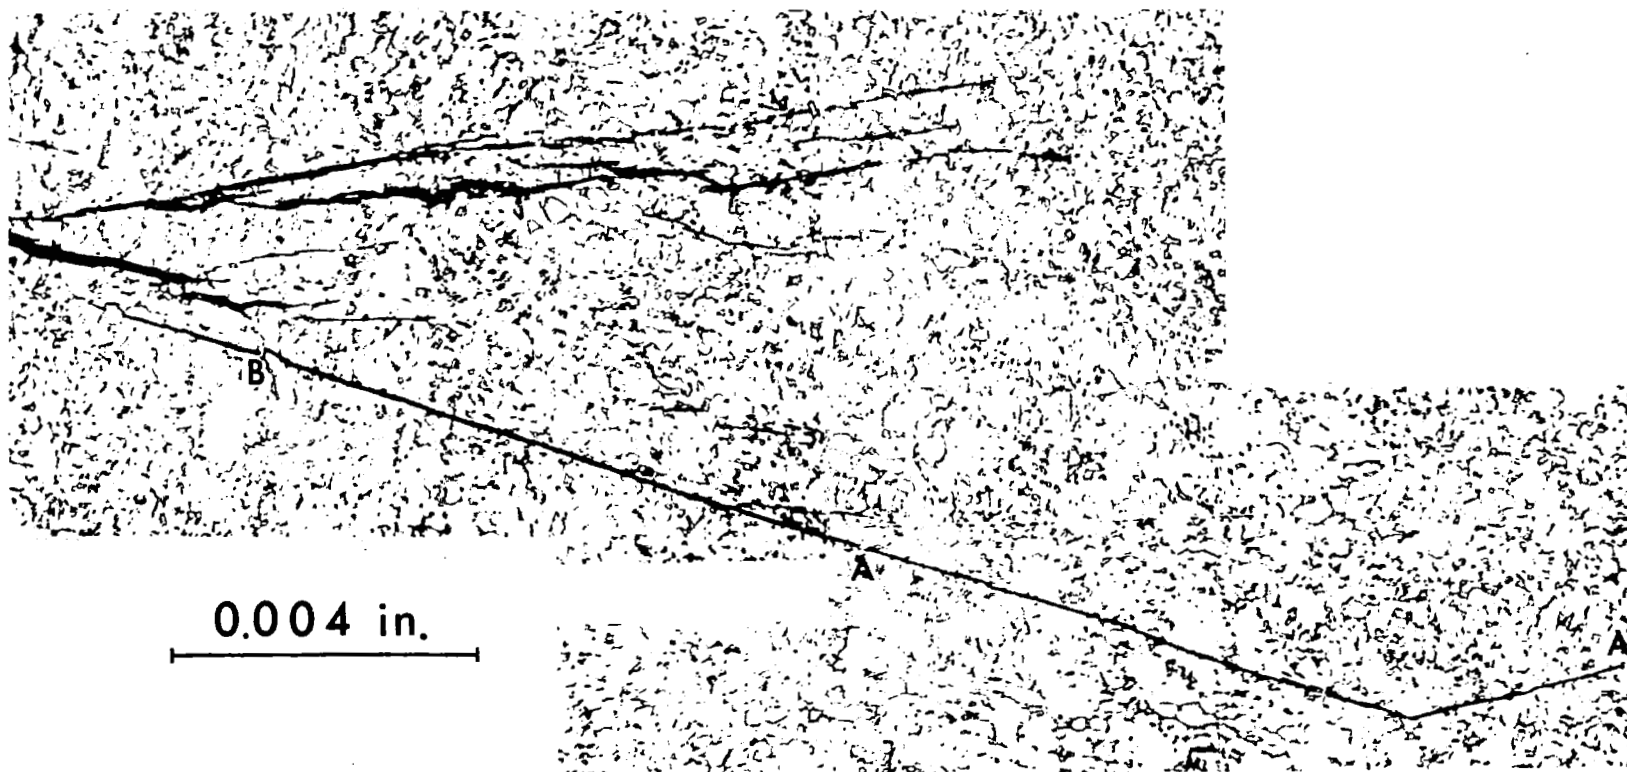
a. "Ragged" Crack Morphology

FIGURE 14. DETAILS OF TWO DIFFERENT CRACK-TIP MORPHOLOGIES

b. Severe Crack Branching

FIGURE 14. (Continued)

- (1) "Ragged" cracks that consisted of straight segments 0.004 to 0.008 inch in length. At the tip of each segment the crack was "wiggly", changing direction from one grain to the next. This type of morphology is illustrated by

Figures 13a, 13c, 13d and 14a, and accounted for the major proportion of the crack front.

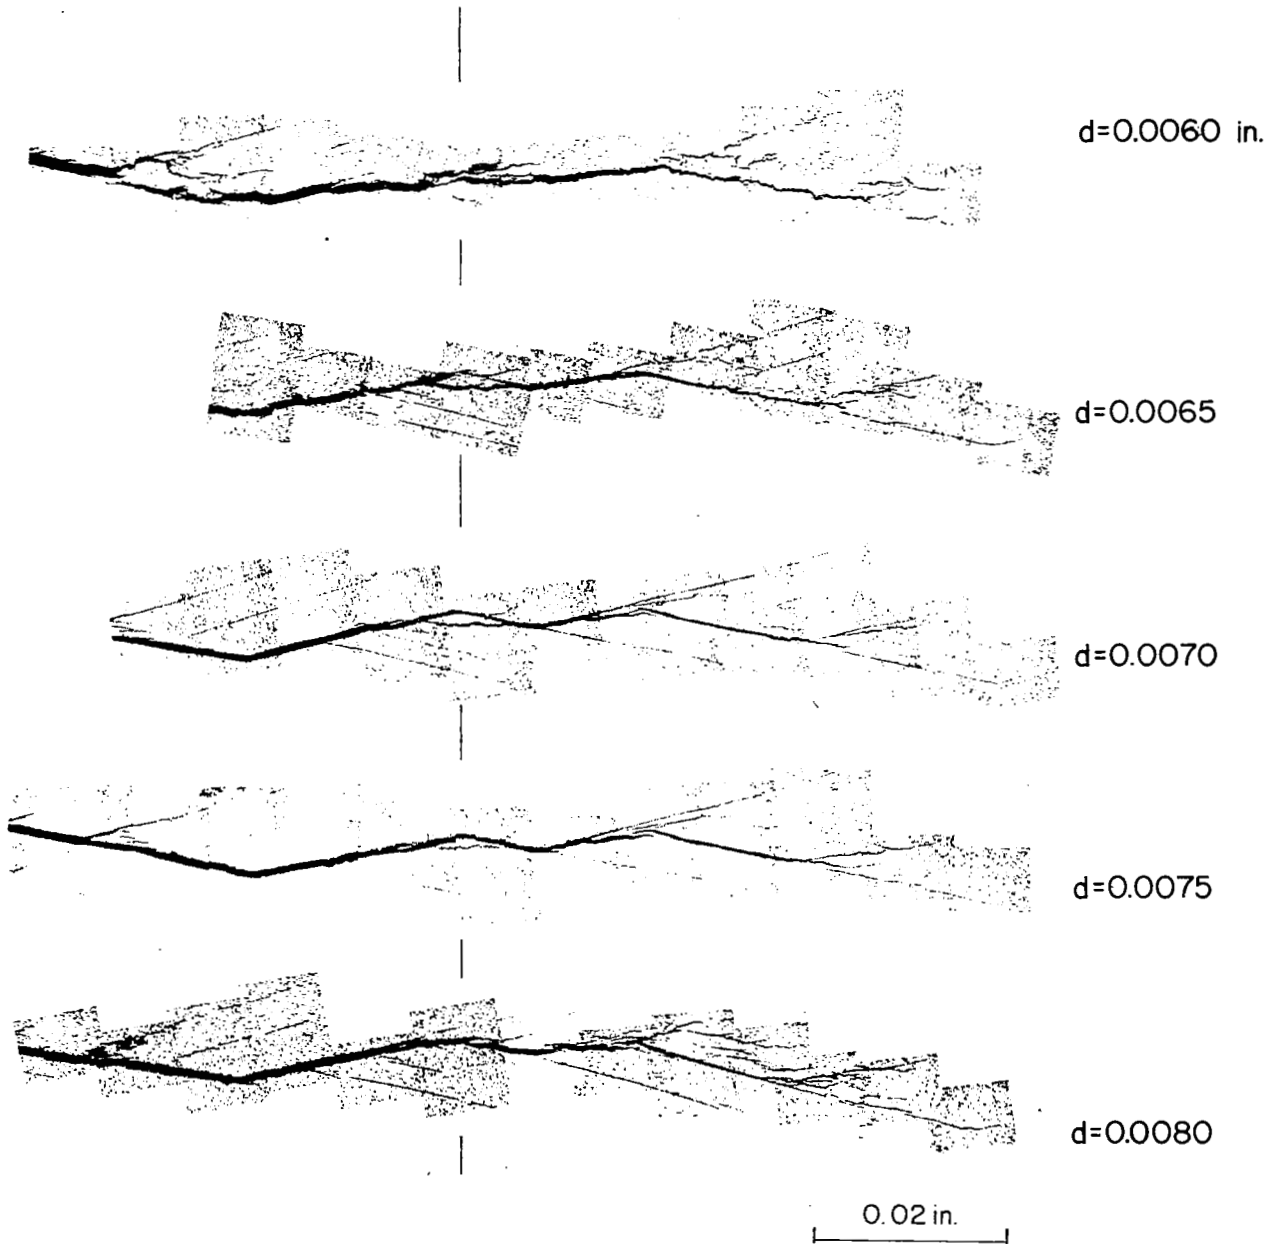
Ti-8 Al-1Mo -IV

3.5 % NaCl
 $K_I = 53 \text{ ksi } \sqrt{\text{in.}}$

FIGURE 15. A THROUGH-THICKNESS SERIES OF MICROGRAPHS SHOWING THE WIDTH OF SEVERELY BRANCHED-CRACK SEGMENTS

Examinations of cracks of various lengths, (i. e., corresponding to various values of K_I at the crack tip) showed that areas of severe branching occurred only near the tips of cracks that had been subjected to high stress intensities. This could be seen by examining the whole length of a single crack. Severe branching was found only near the tip where the stress intensity had been highest. There was no evidence of severe branching toward the other end of the crack which had sustained only low stress intensities.

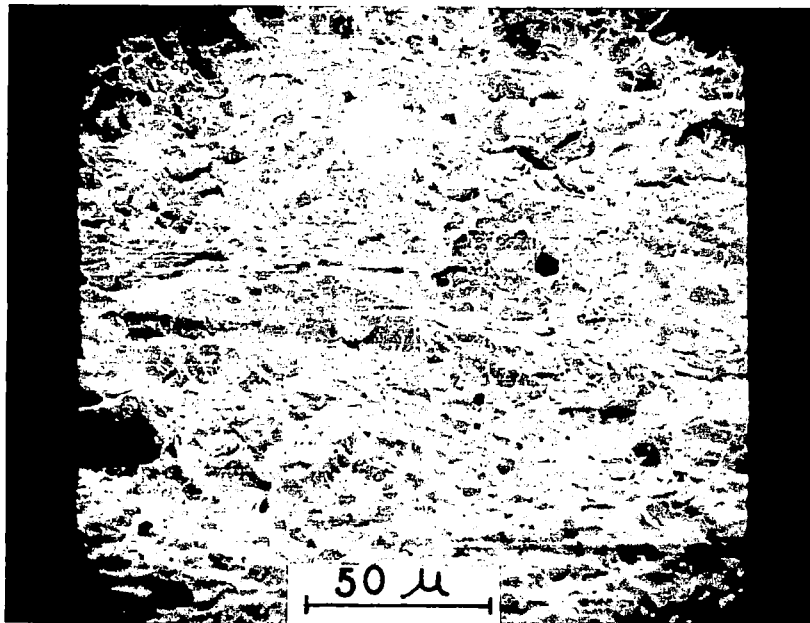
FIGURE 16. SCANNING ELECTRON MICROGRAPH OF AN AREA OF RAPID FRACTURE

Fractography. Scanning electron microscopy examination of fractured surfaces revealed certain features that were peculiar to the subcritical-cracking mechanism. Areas of rapid fracture exhibited the "cup-cone" failure mode* characteristic of ductile rupture (Figure 16). This was the case for rapid fracture in air as well as in aqueous environments. By contrast, the fracture surfaces resulting from subcritical cracking exhibited a high density of cleavage facets. In areas which had been subjected to a high stress intensity, ($> 2 K_{I_{SCC}}$), two distinct morphologies were observed. The first consisted of large, flat cleavage facets that tended to be elongated in the direction of crack propagation. This morphology is illustrated by the area at the top of Figure 17a (Area A), where the "river lines" running near to the average crack propagation direction are clearly visible. These facets were typically 50 to 200 microns long and 20 to 50 microns wide. Stereo microscopy revealed that these cleavage facets were not parallel to the macroscopic fracture surface. For example, the facet marked A (Figure 17a), is inclined such that it is down to the left and up to the right. The second morphology is illustrated by the area towards the bottom of Figure 17a (Area B). This fracture mode gave a much more irregular surface. There was still much evidence of cleavage, but here the cleavage facets were smaller (\approx the mean grain size), equiaxed, and inclined at various angles to the macroscopic fracture surface. There was also evidence of intergranular fracture, and deep crevices and pits. Another area illustrating this fracture mode is shown in Figure 17b.

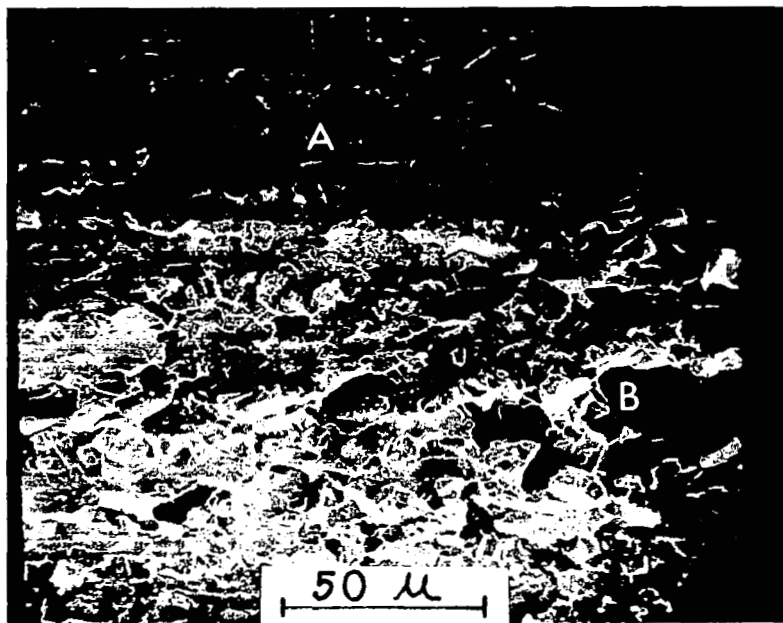
FIGURE 17. SCANNING ELECTRON MICROGRAPHS FROM AREAS OF STRESS-CORROSION FRACTURE

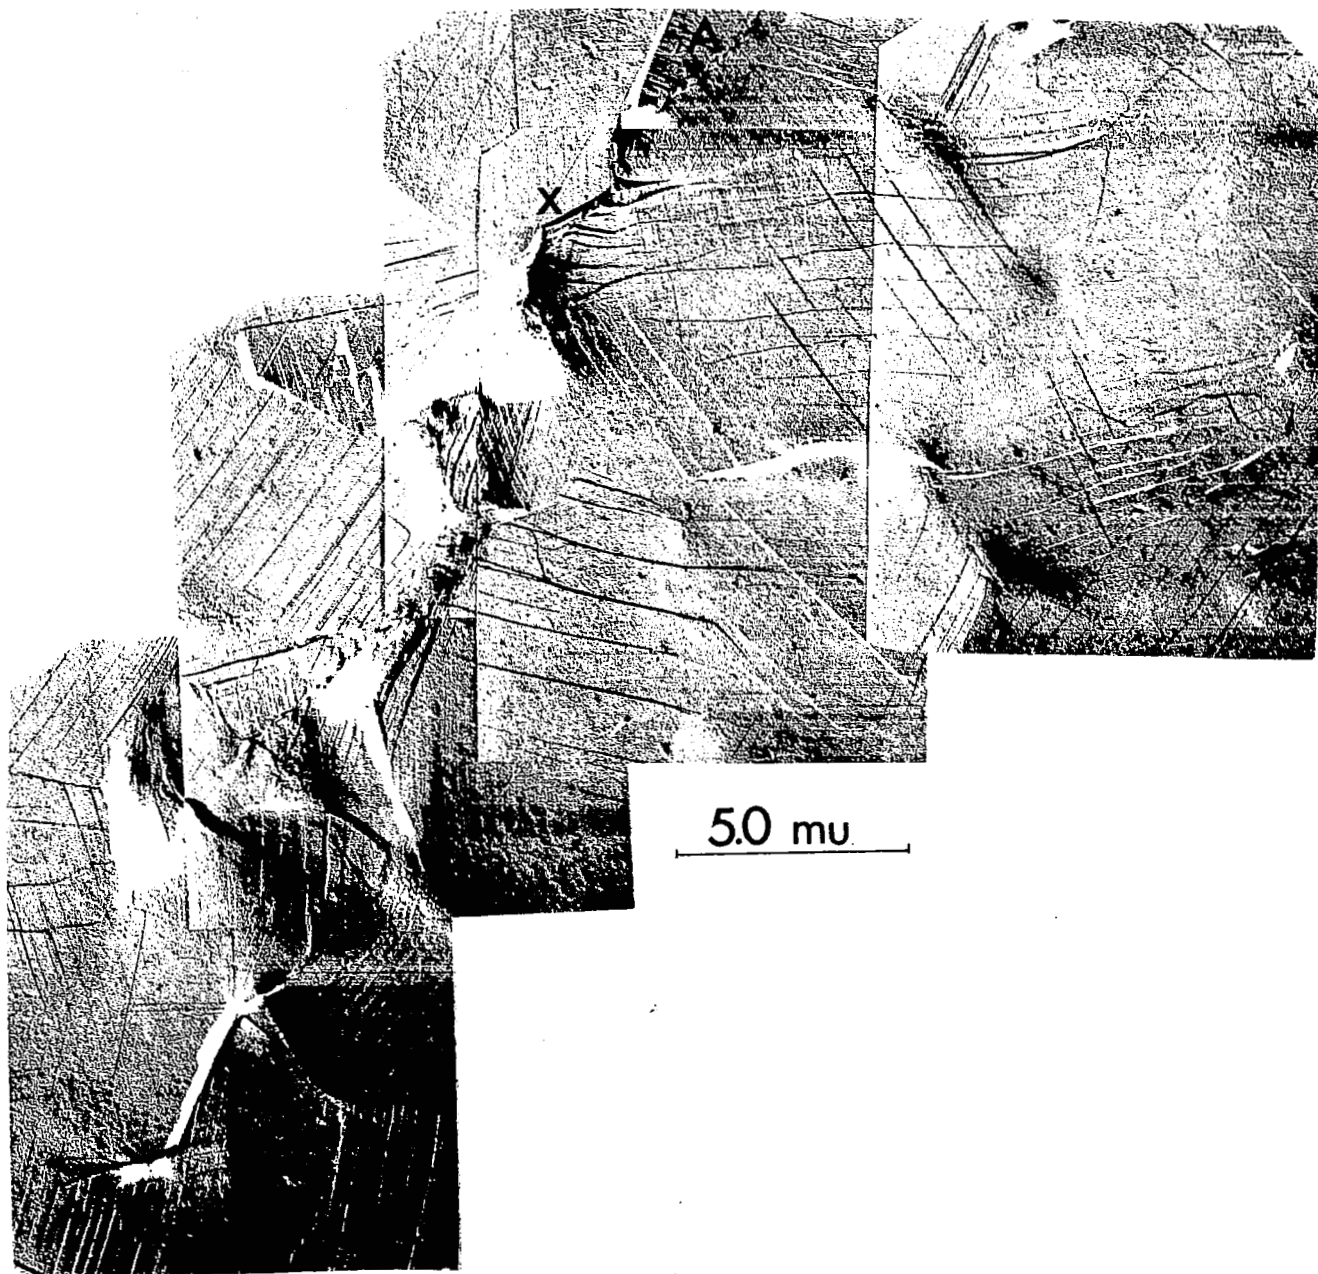
FIGURE 18. ELECTRON MICROGRAPH OF A TWO-STAGE CARBON REPLICA, ILLUSTRATING THE DISTRIBUTION OF SLIP AROUND A STRESS-CORROSION CRACK

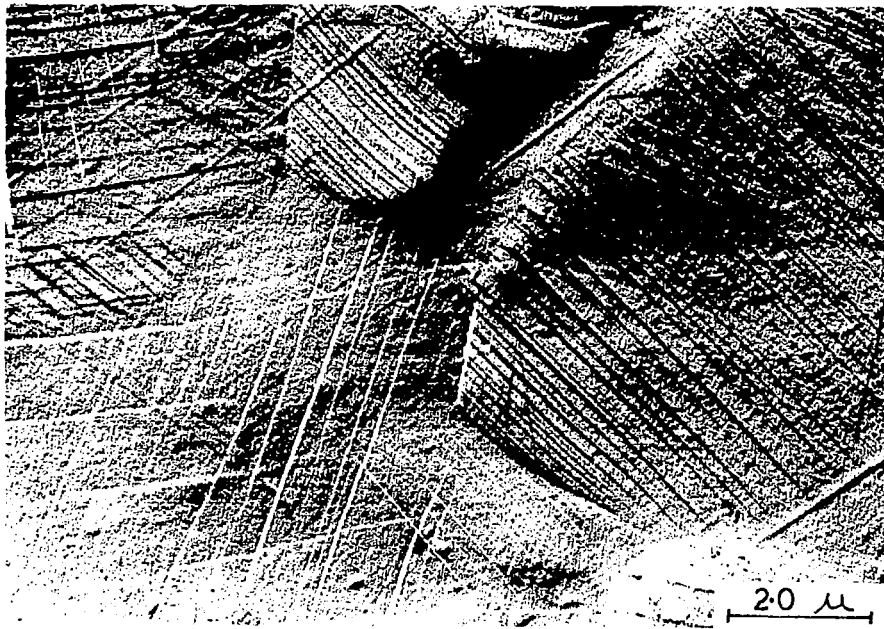
FIGURE 19. NONHOMOGENEOUS SLIP IN THE PLASTIC ZONE OF A STRESS-CORROSION CRACK
